Cloned from Removal File  
I- Action memo

## II. SITE CONDITIONS AND BACKGROUND

**ASSESSMENT OF SCIO POTTERY  
SCIO, OHIO**

VISUAL SITE INSPECTION REPORT

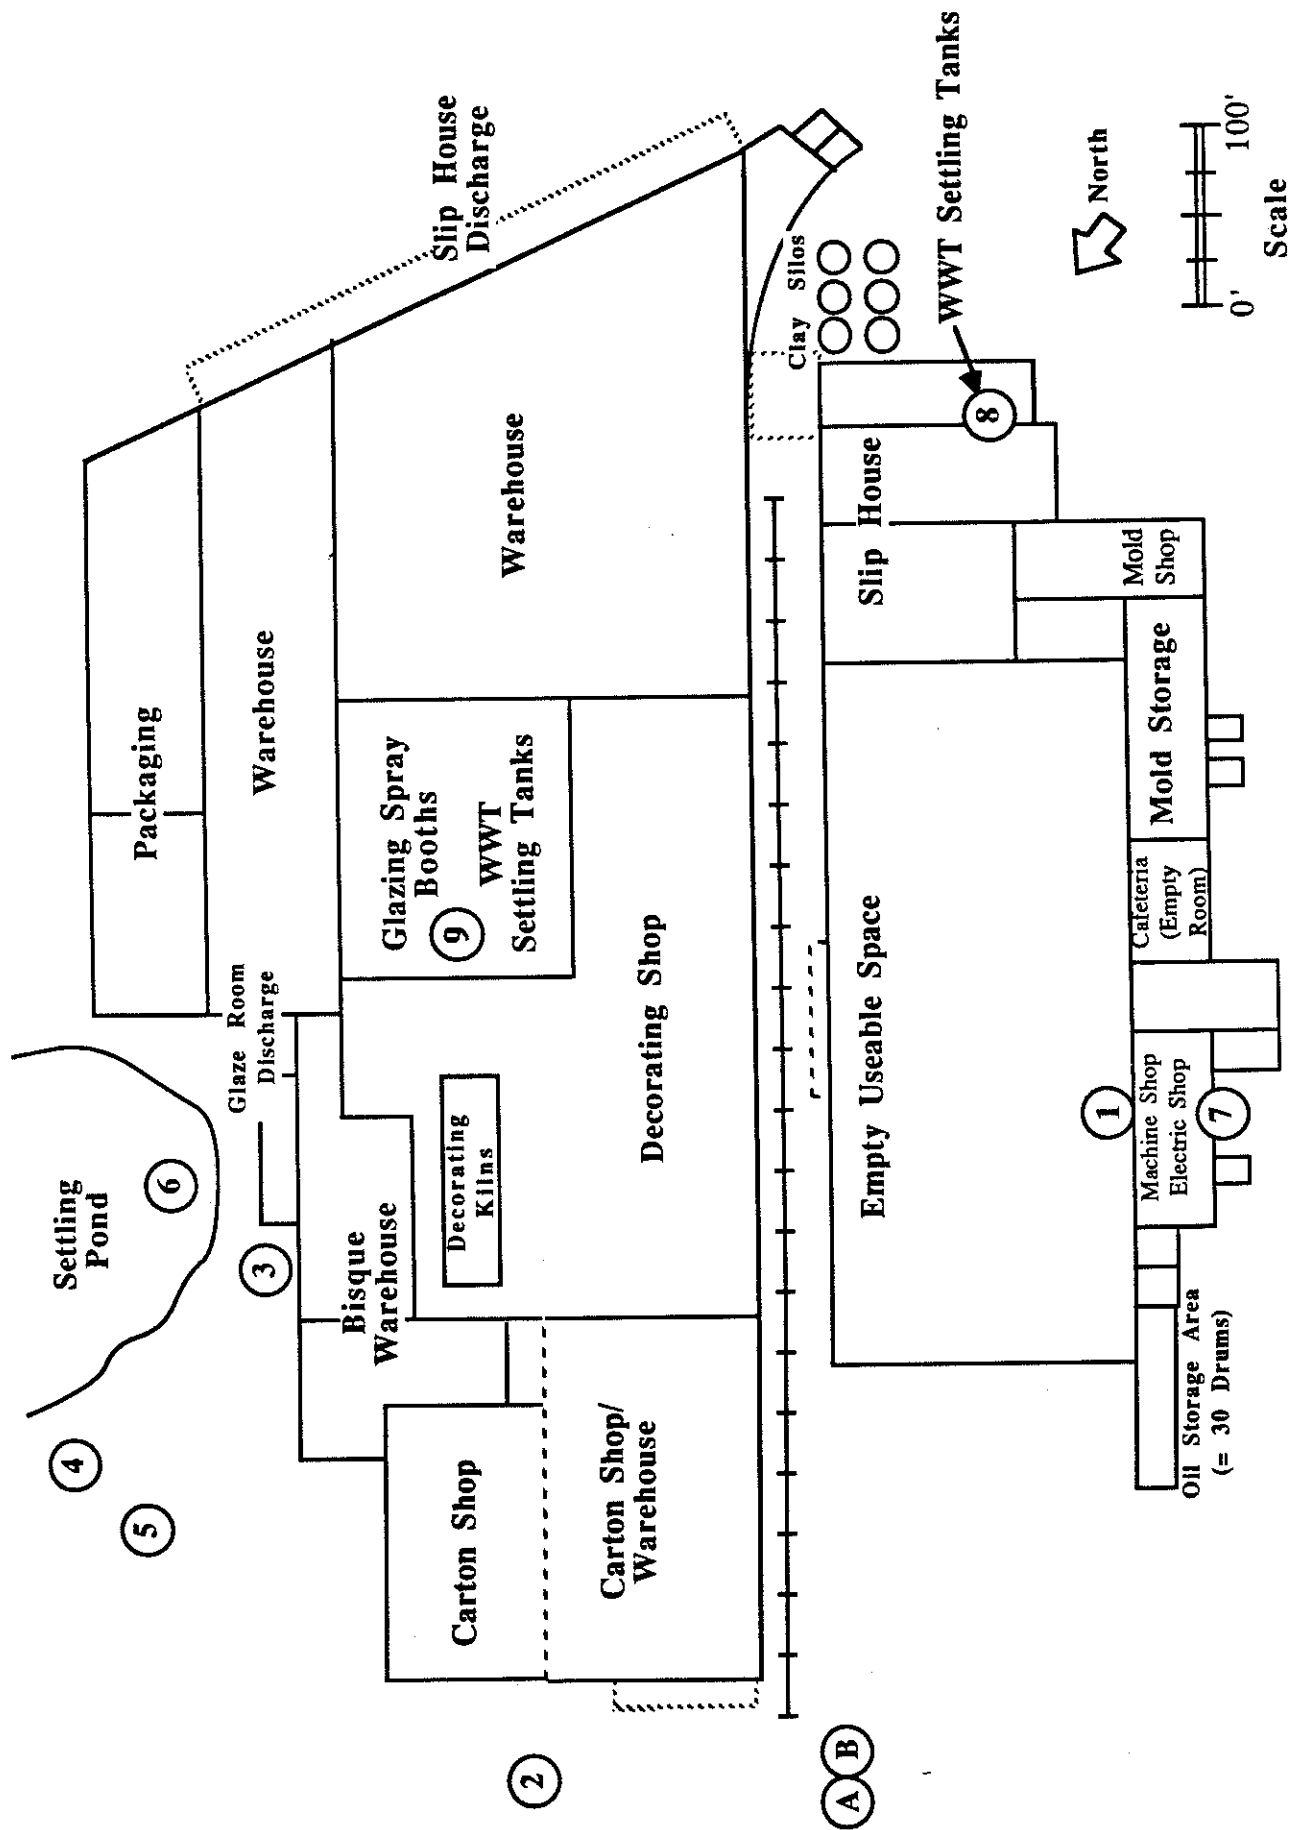
**Figure 2 SCIO Pottery Company  
Facility Layout and SWMU Locations**

(Circled Numerals Designated  
SWMU Locations)

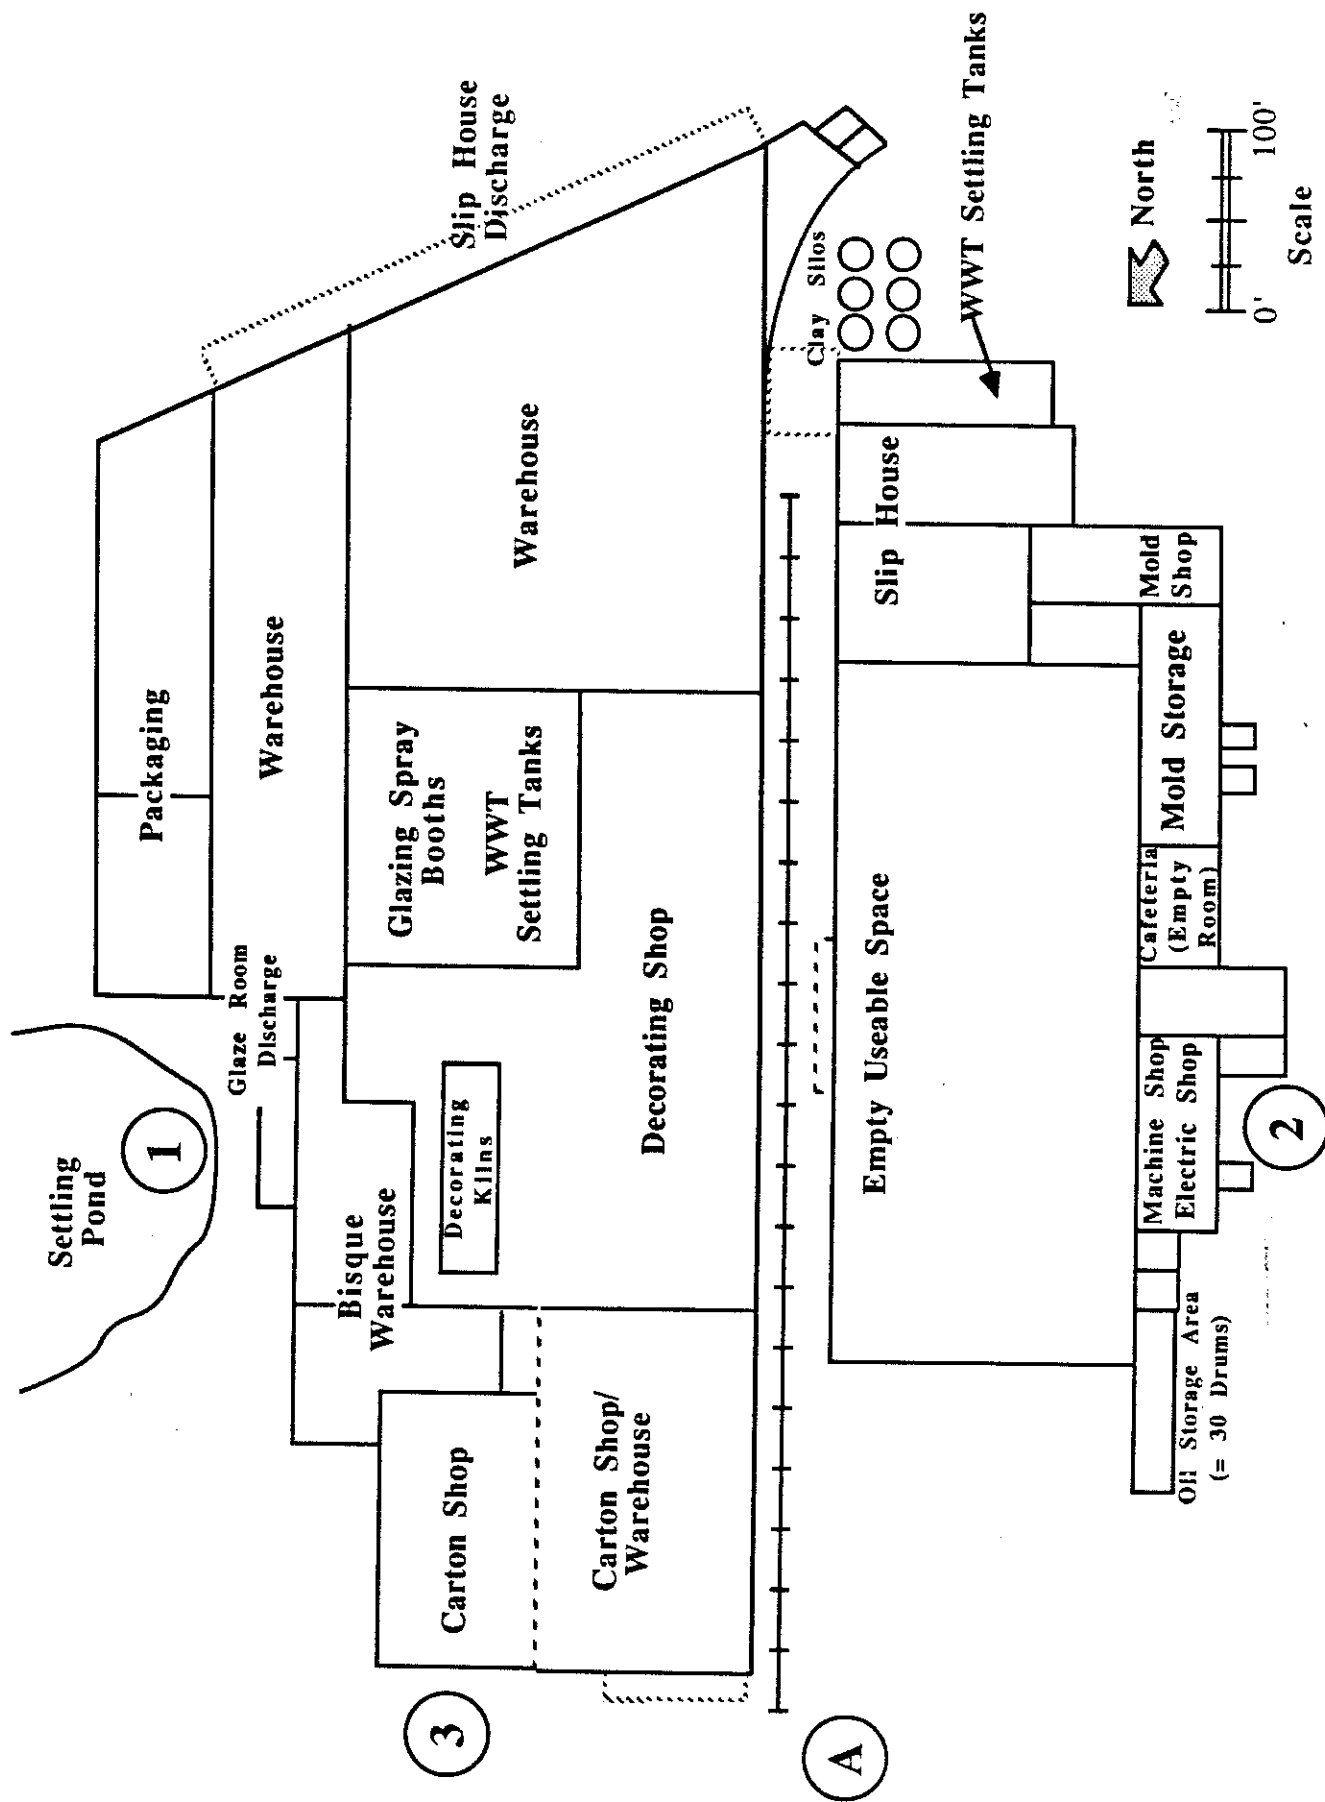
**Figure 2 Scio Pottery Company  
Facility Layout and SWMU Locations**

(Circled numerals designate  
SWMU Locations)

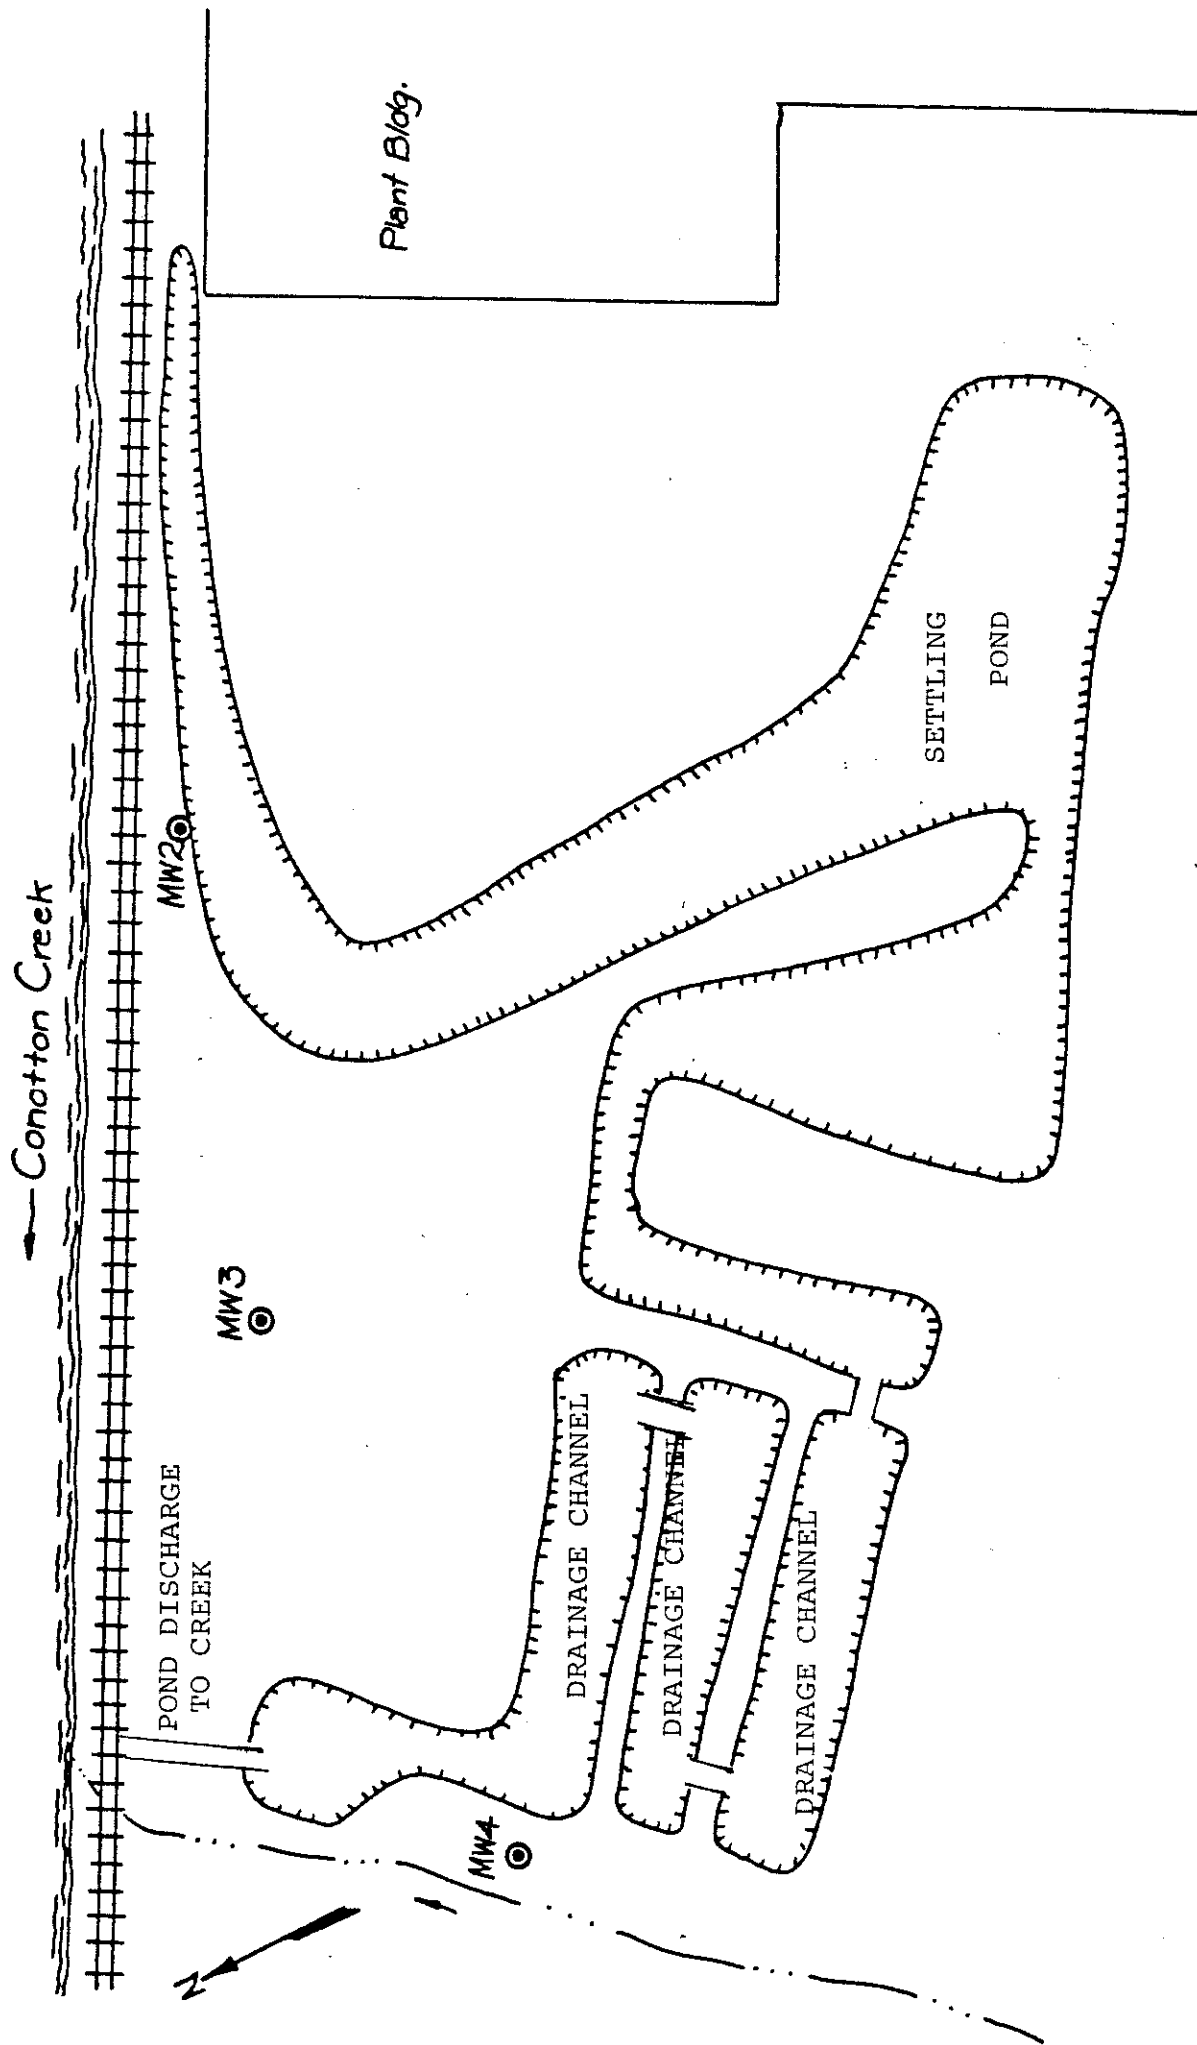
Figure 4. Scio Pottery Settling Pond

● Water Well

● MW1

- Release Controls:** No release controls were noted. The unit is unlined. Four monitoring wells have recently been installed in the vicinity of this unit (see Figure 4) (Reference 7).

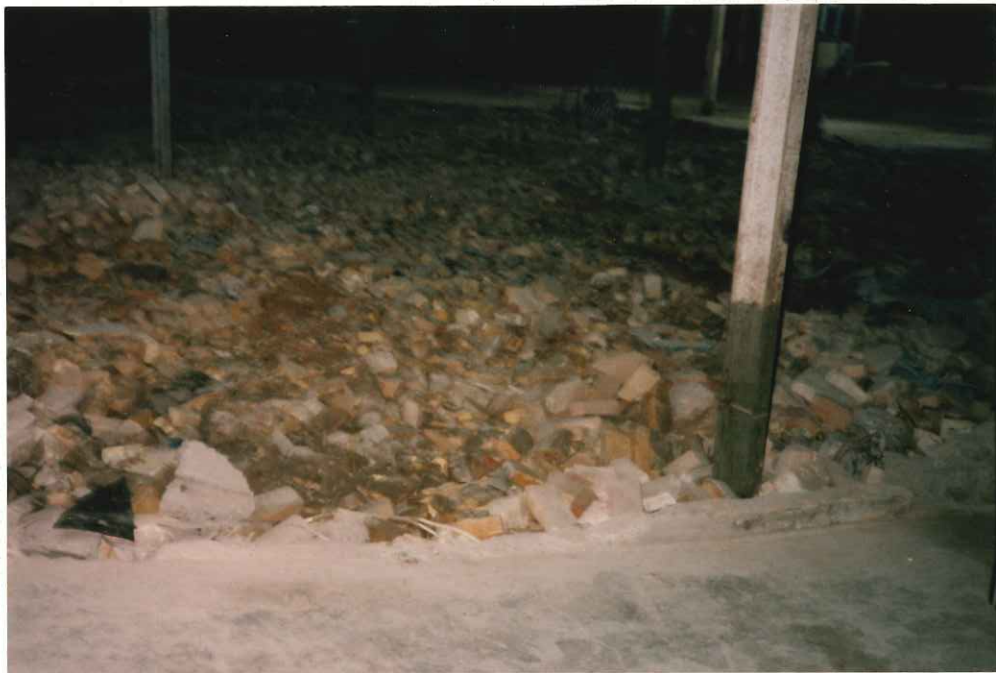
Photo 1: Open Area, currently under renovation.  
Debris consists primarily of bricks.

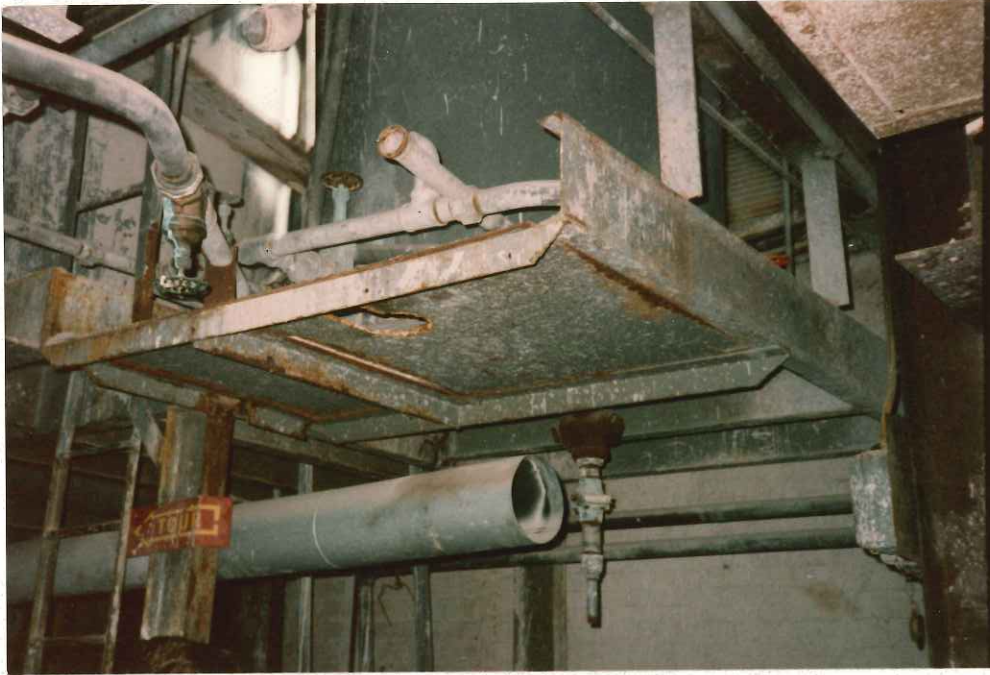
Photo 3: Plant Production Area, currently under renovation. Drain pipes originally led to underground slip recycling tanks.

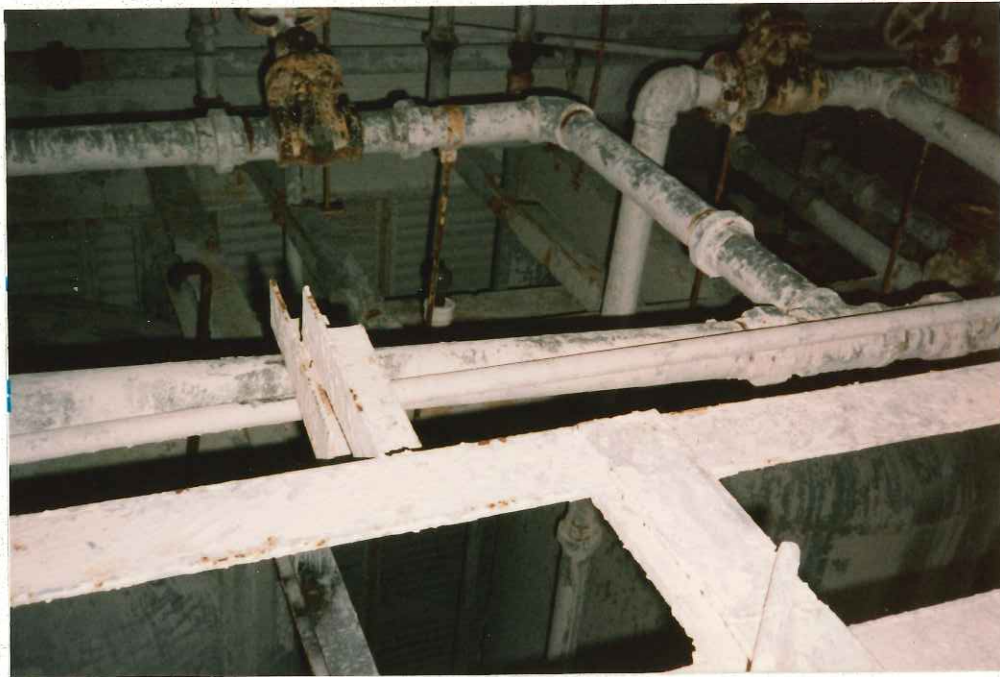
Photo 13: Production Area: Slip Tanks which usually contain recycled liquid clay (4 tanks total)

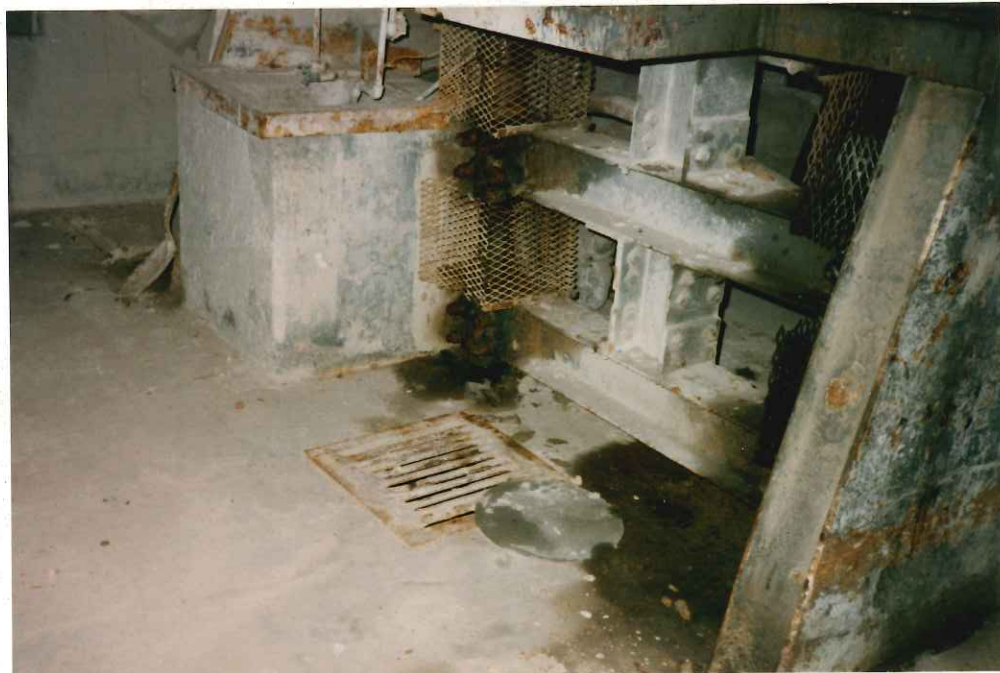
Photo 14: Grate above recycling holding tank. The tanks are located in a concrete and have a total capacity of approximately 1,000 gallons. The tanks are cleaned regularly by taking the lid off and lifting out the sludge.

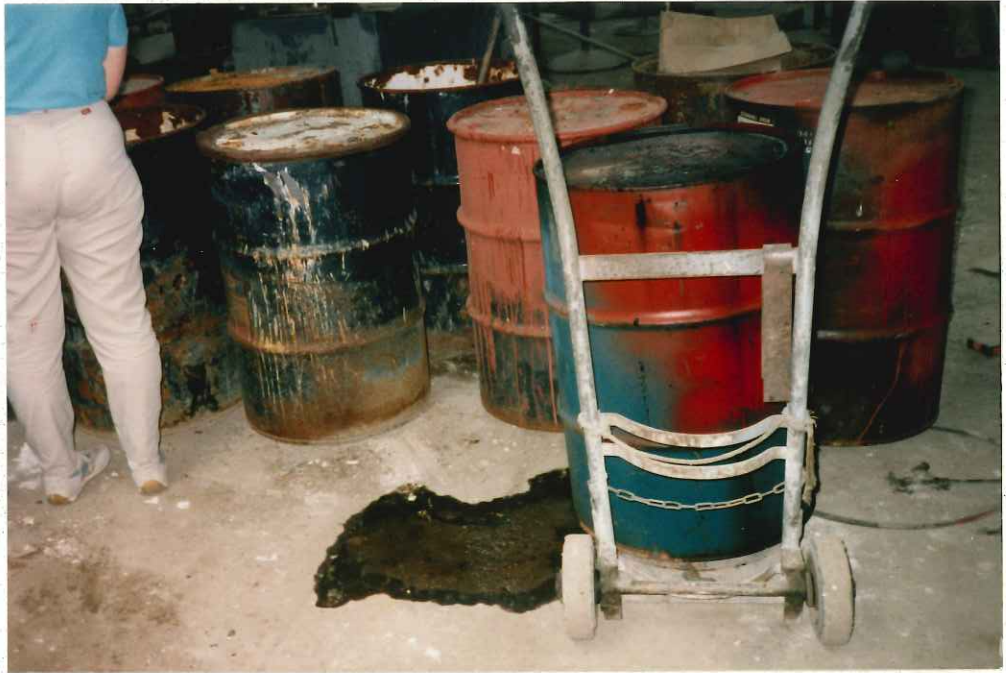
Photo 15: SWMU No. 1 - Drums containing waste paint and motor oil. Note oil spill in center of photograph.

Release History: An oil spill was noted during the VSI on the concrete floor within the drum storage area.

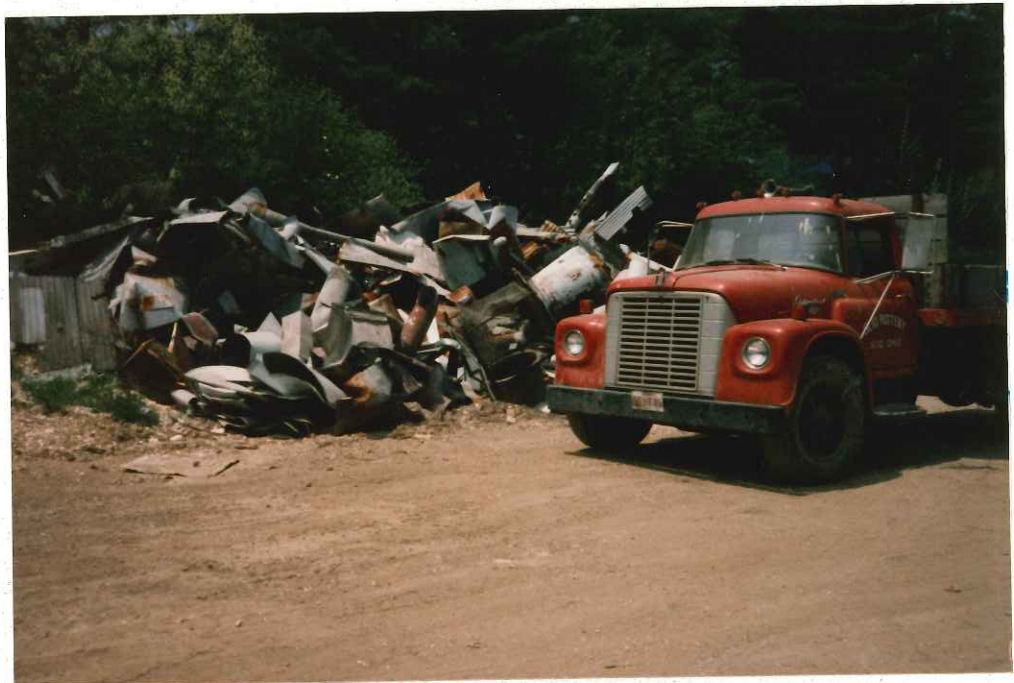
Photo 16: SWMU No. 2 - Scrap Storage Area from current renovation. Direction of photo is east.

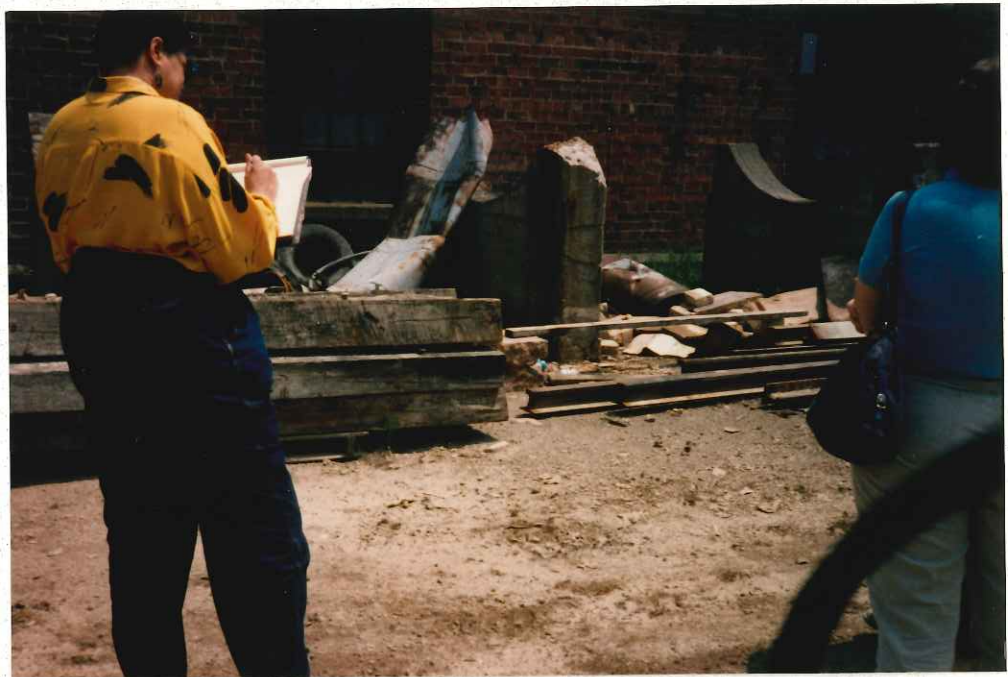
Photo 17: SWMU No. 3 - Oil Storage Area, last used during World War II. Direction of photo is west.

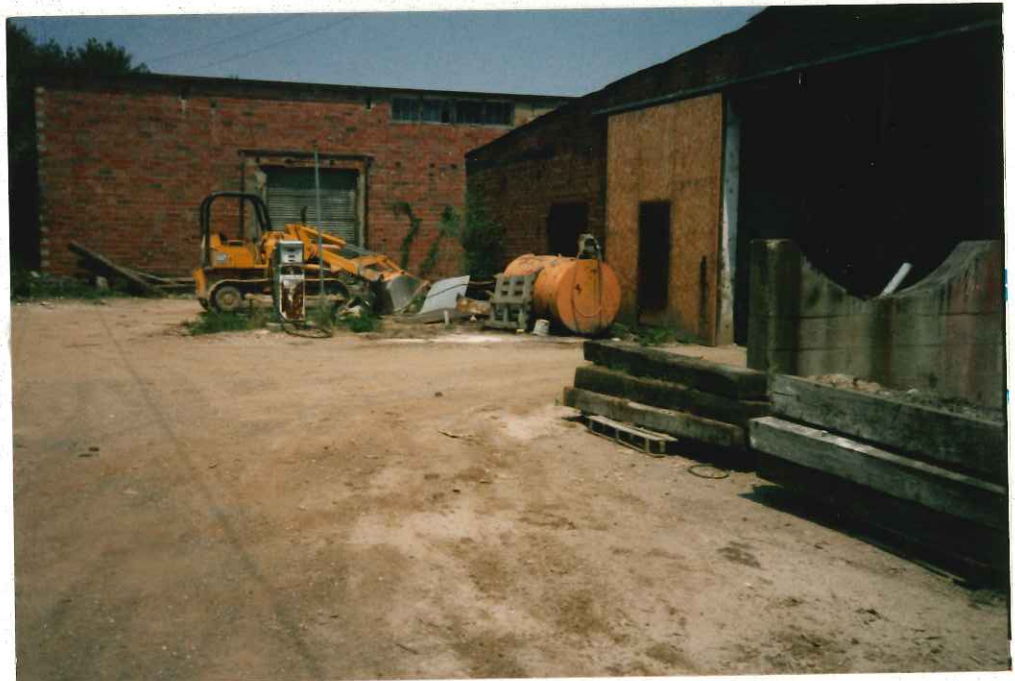
Photo 18: Other Area of Concern A - Underground 1,000 gallon storage tank. The unit is in the area of the gasoline pump.

Other Area of Concern B - Aboveground 500 gallon storage tank. Unit contains kerosene.

Direction of photo is south.

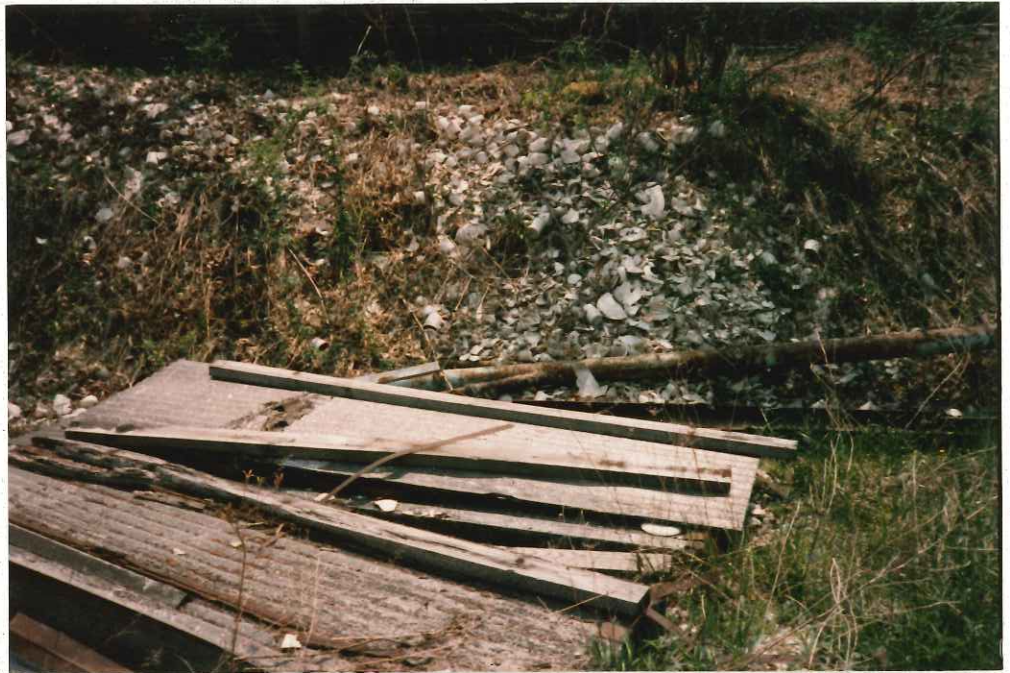
Photo 19: SWMU No. 4 - The lower portion of photograph is a Scrap Storage Area during renovation. The unit contains wood rubble and rusted pipe.

SWMU No. 5 - The upper portion of the photograph contains broken pottery fill. Broken pottery fill is found throughout the rear of the facility.

Unit Description: Broken pottery is used as fill in the entire area between the pond and the Settling Pond (SWMU No. 6). The broken pottery consists of broken dishes, cups and saucers.

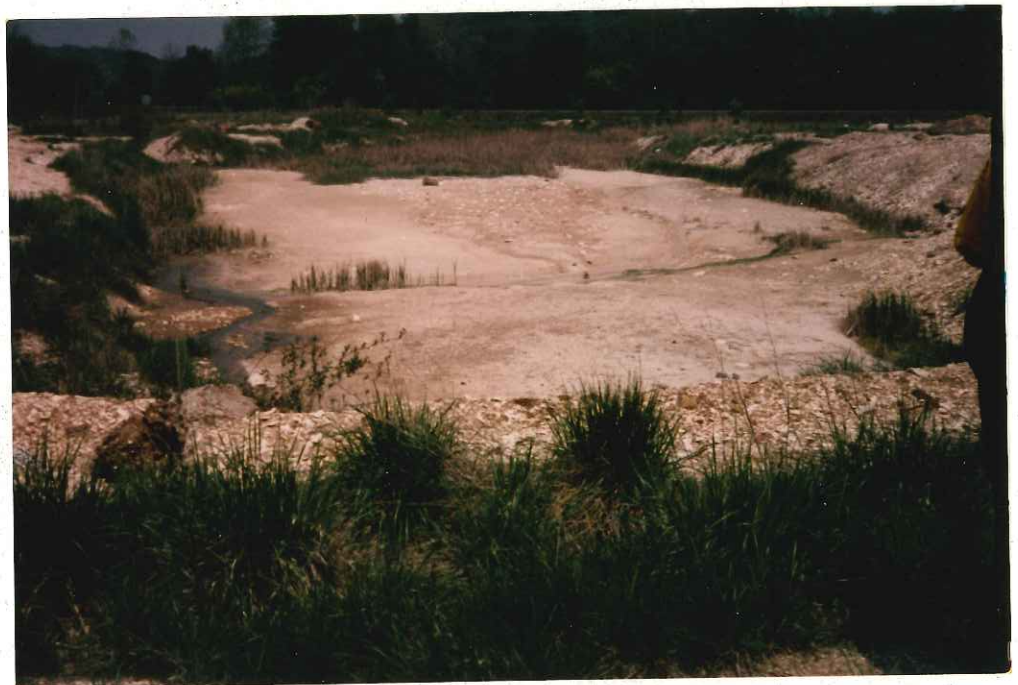
Photo 20: SWMU No. 6 - Setting Pond; direction of photo is east. Note embankment is covered with broken pottery.

20. Settling Pond, Substantially  
covered w/ broken dishes.

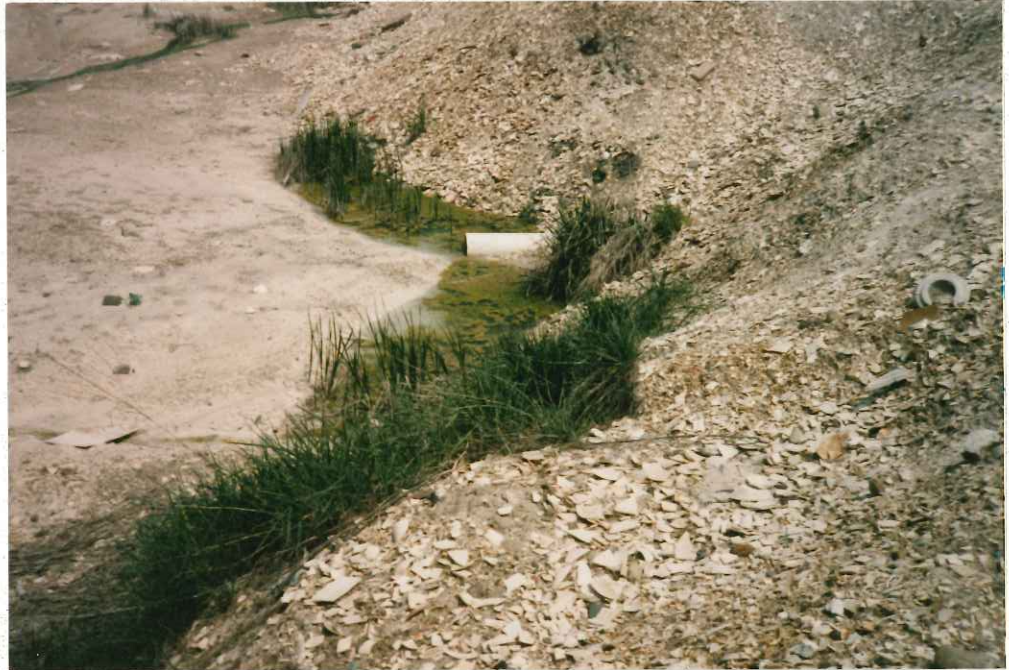
Photo 21: SWMU No. 6 - Settling Pond; direction of photo is east. Note discharge pipe in photo center. Also, note embankment is covered with broken pottery.

21. Pipe discharge from  
pumping operation. Equipment  
collects runoff from  
parking lot. Water was  
observed still running.  
Depth of the SP is 6-8'.

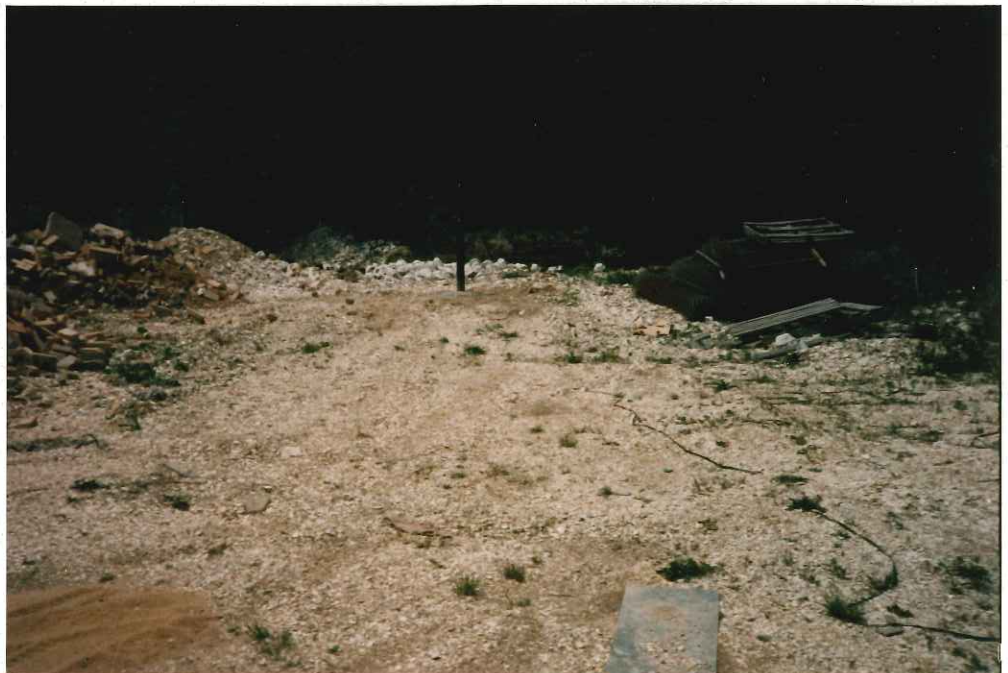
Photo 22: Monitoring Well No. 1 in center of photograph. Direction of photograph is northeast.

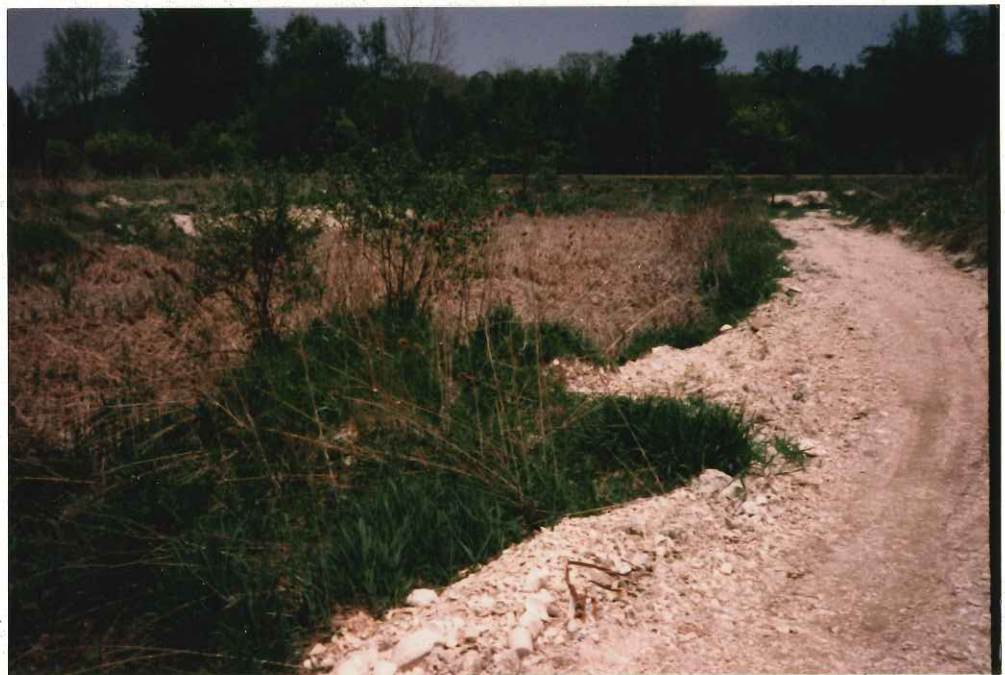
Photo 24: SWMU No. 6 - Settling Pond; direction of photo is south. Note embankment and road covered with broken pottery.

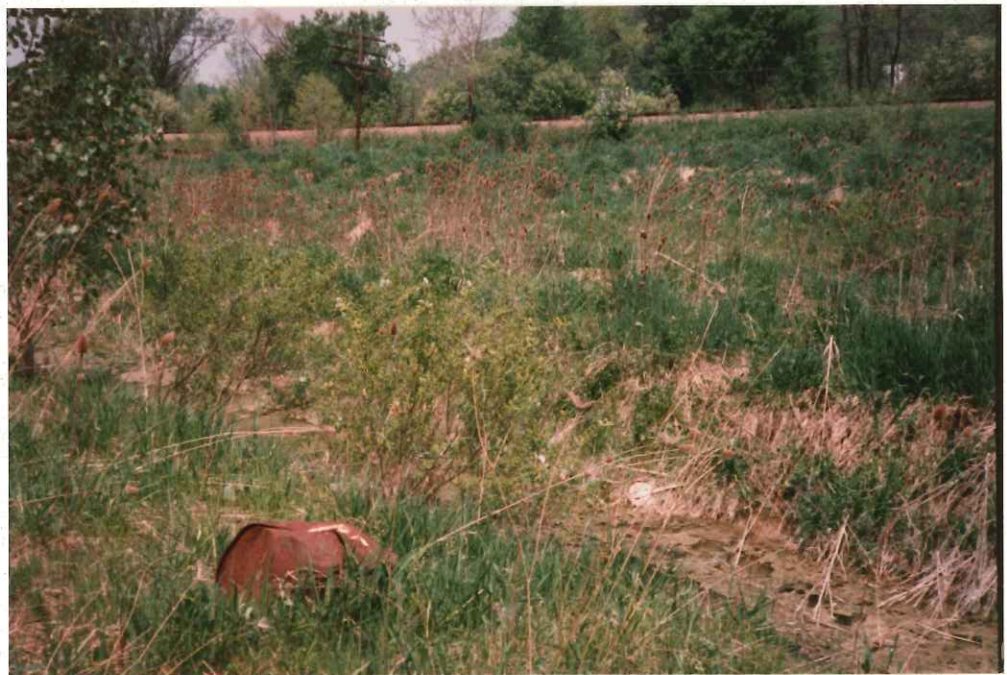
Photo 26: SWMU No. 6 - Settling Pond Drainage Channel;  
direction of photo is east. Note rusted drum in  
foreground and stagnant water in channel. Also note  
railroad tracks in background.

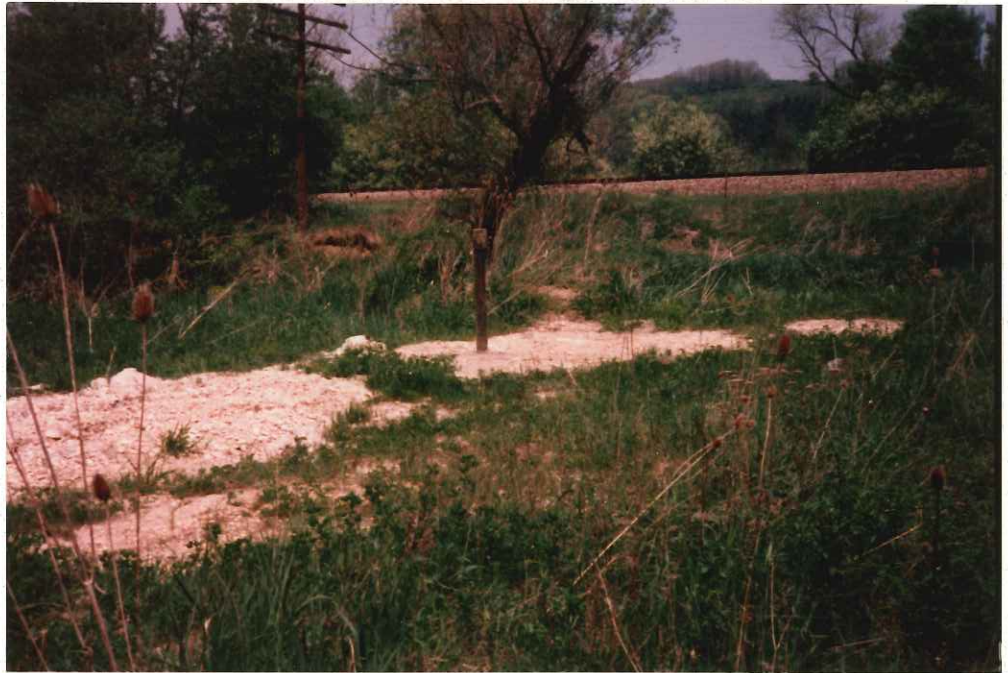
**Photo 27:** Monitoring Well No. 4 in center of photograph.  
Direction of photo is north.

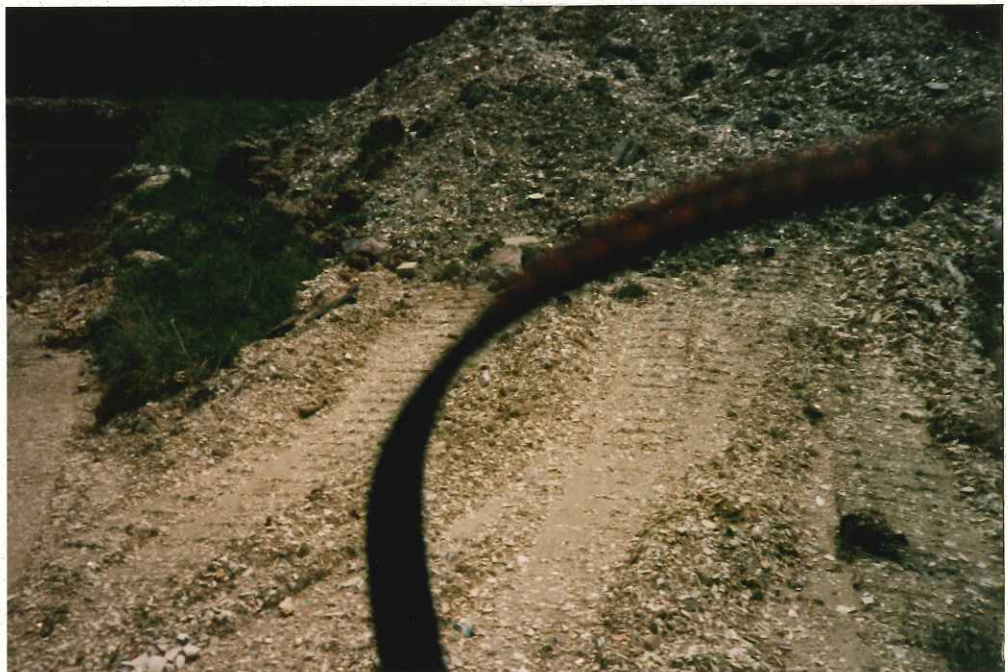
Photo 30: Natural Gas Line (upper left of photograph); note broken pottery on Settling Pond embankment.

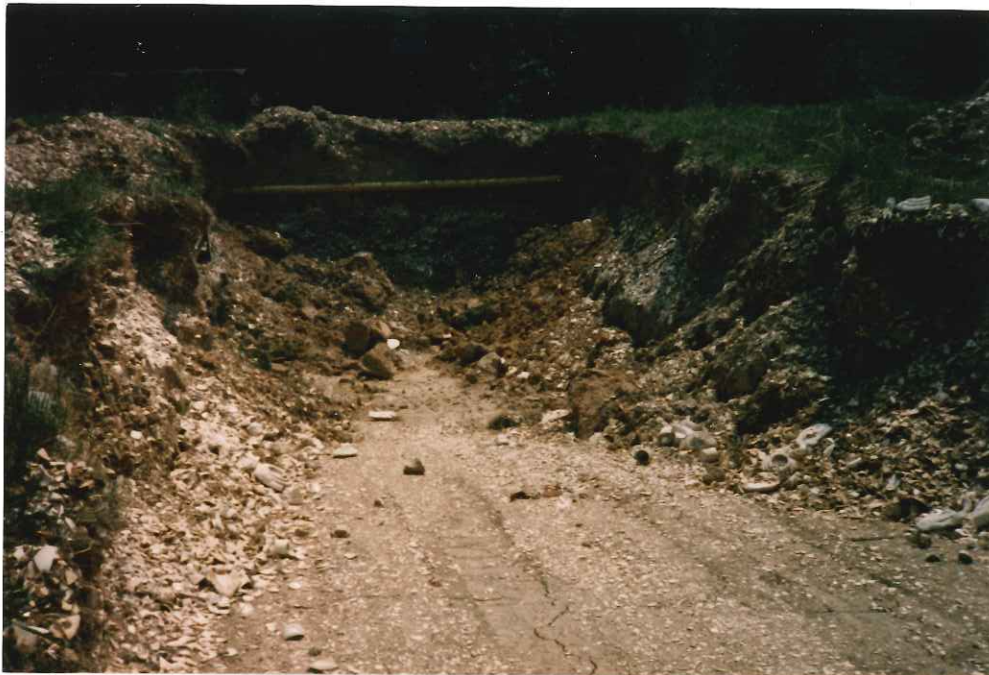
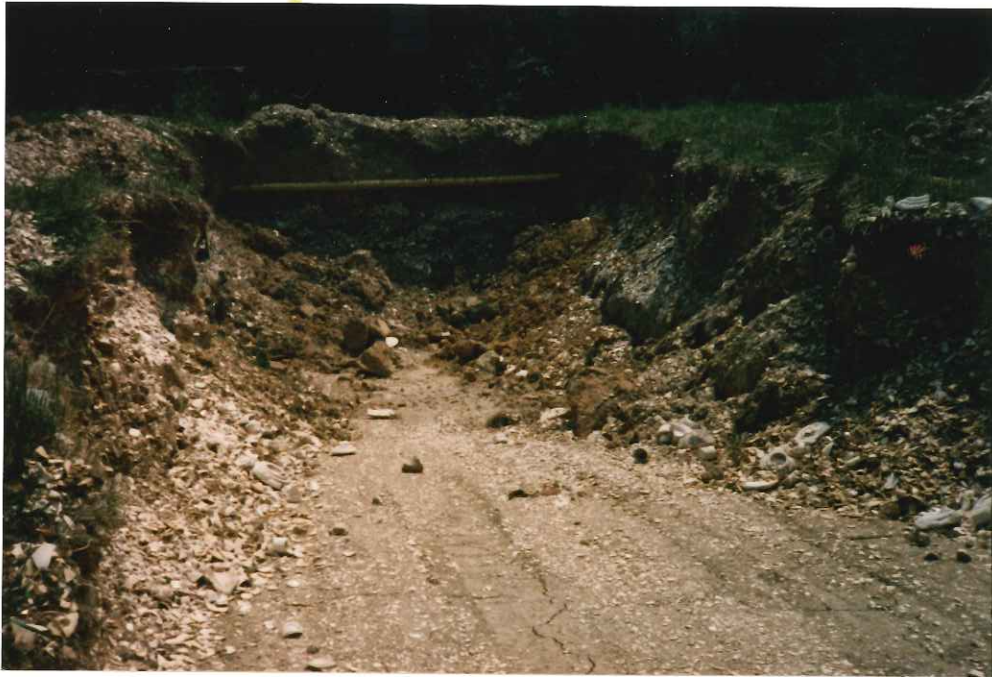
Photo 31: Natural Gas Line in cross section of fill.

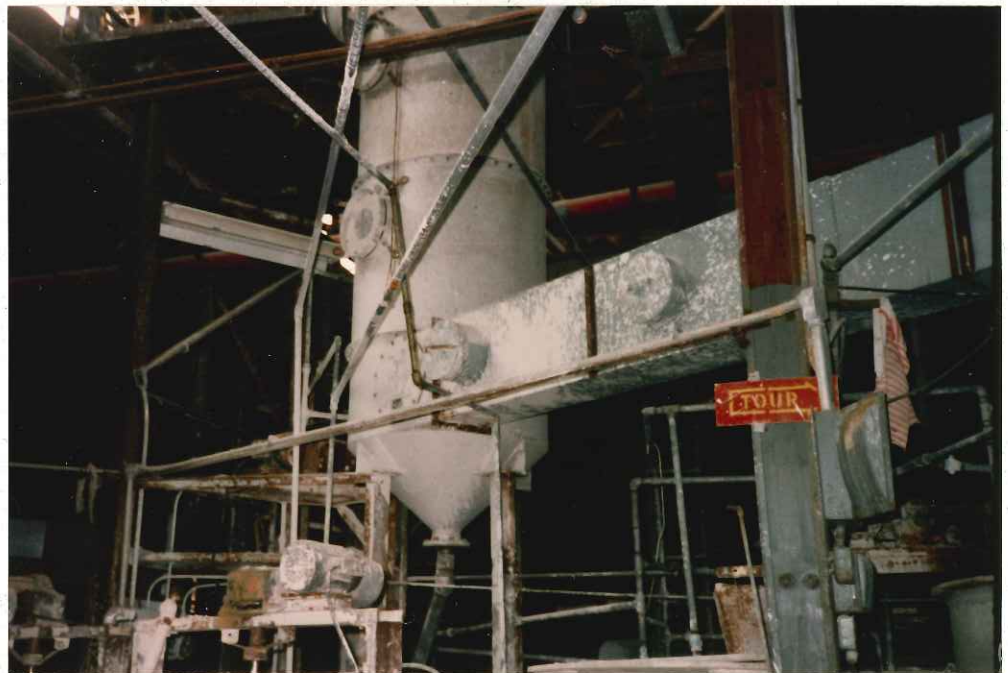
Photo 34: Production Area - DUCON Recovery System  
(Stainless Steel Recovery System)
